Board memo

Subject: Board Concurrence – Oregon amendment relative to anchorage of bolts in concrete supporting wood plate sills/walls. IBC 1908.1.16 [ACI 318 D3.3.5].

SEAOC Blue Book – Seismic Design Recommendations Anchor Bolts in Light-Frame Construction at Small Edge Distances

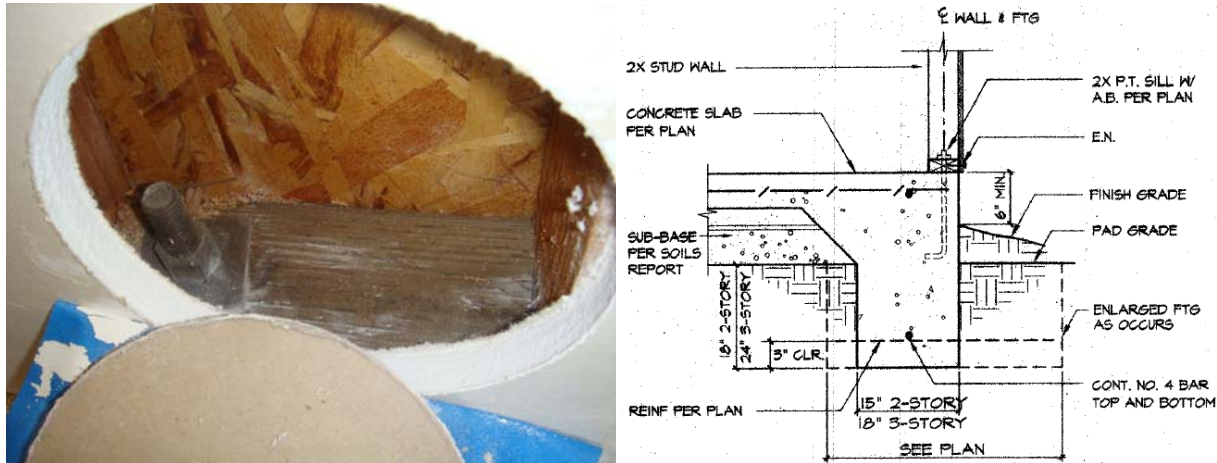
Image 1 – View of an “as-built” anchor bolt installation per plan detail with minimum edge distance of approximately 1-3/4”. Anchor shown is 5/8” nominal diameter with a 2”x2” plate washer per CBC-2001. Note CBC-2007 requires 3”x3”x0.229” plate washer.

Seismic force resisting systems for wood framed buildings typically comprise wood structural panel shear walls with anchor bolts located at the edge of foundations. These connections often have specified edge distance of 1-3/4" from the bolt center line to the face of the concrete slab or footing.

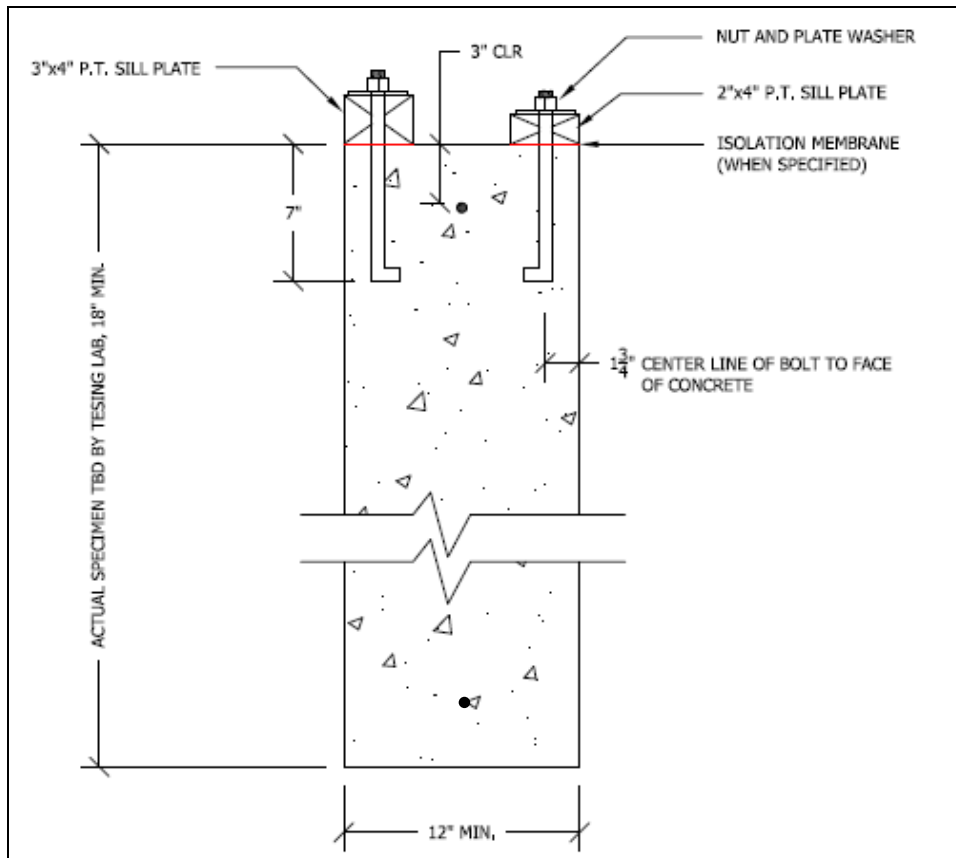
Figure 1 – Typical section for test specimens. Not to scale.

Figure 1 shows a typical cross section of test specimens specified. Material properties are tabulated below. Material properties for each test are included in **Table-1 (primary tests)** and **Table-2 (“bonus” tests)**.

The anchors tested (parallel to the concrete face) were cast-in-place in two rows as shown in **Figure 1**. Interaction between the two rows of anchors and effects on test results was shown to be a non-issue during initial experiments with anchors cast down each side of a narrow concrete section.

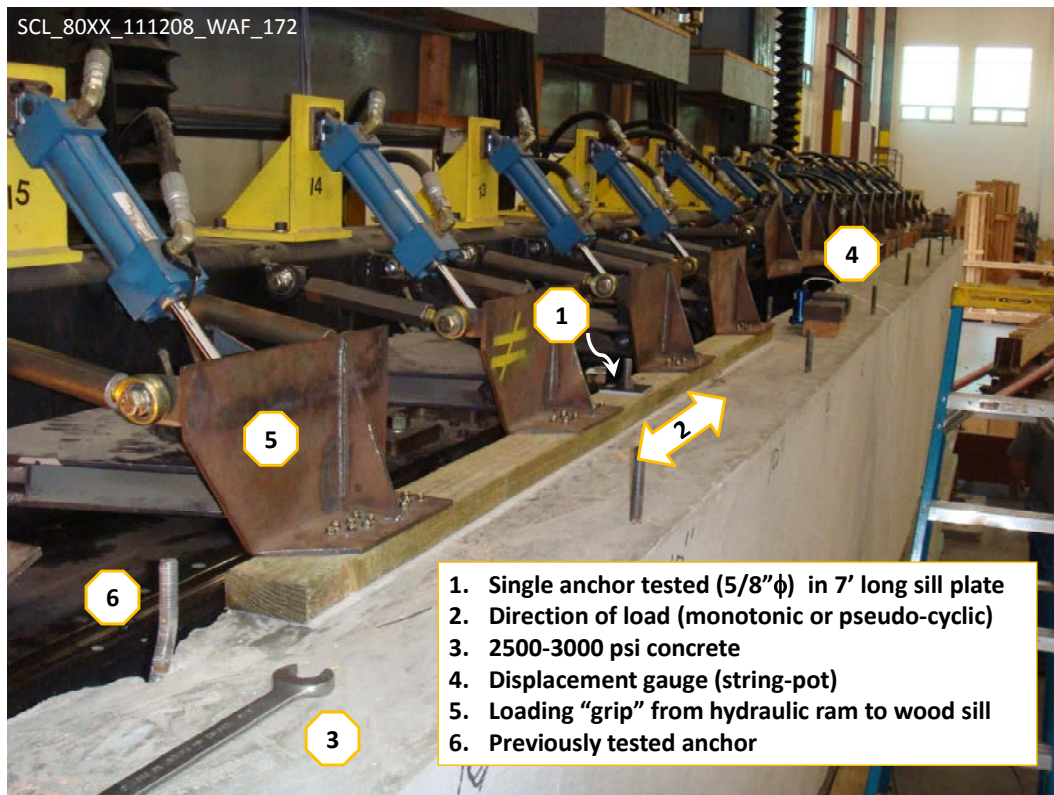
Image 2 – Typical set-up for anchor tests at Tyrell Gilb Research Laboratory in Stockton, CA.

The primary tests were conducted at the Tyrell Gilb Research Laboratory in Stockton, California. The laboratory is owned and operated by the Simpson Strong-Tie Company (SSTC) who generously agreed to donate materiel and testing services to this project. The majority of the testing occurred between November 12-14, 2008 (four tests were completed on November 19, 2008). **Image 2** is an annotated image showing the typical set-up for the single-anchor tests.

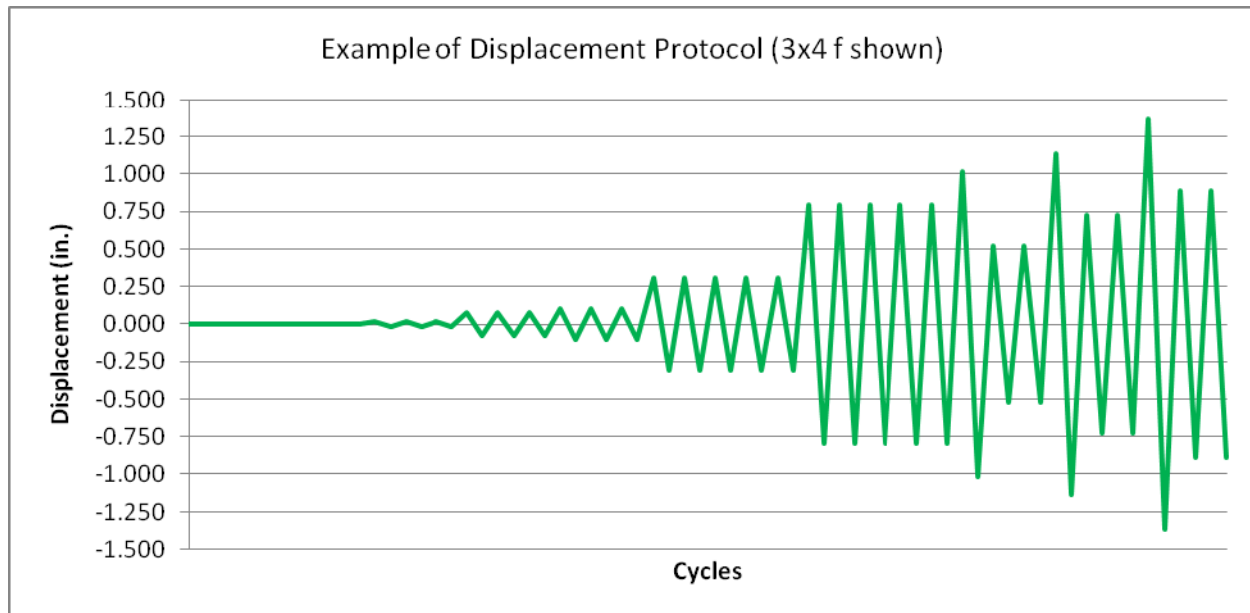
Image 3 – Graphical example plot of inputs for displacement-controlled cyclic tests

Table 3 – Inputs for displacement-controlled cyclic tests. See Image 3 below for a graphical example plot.

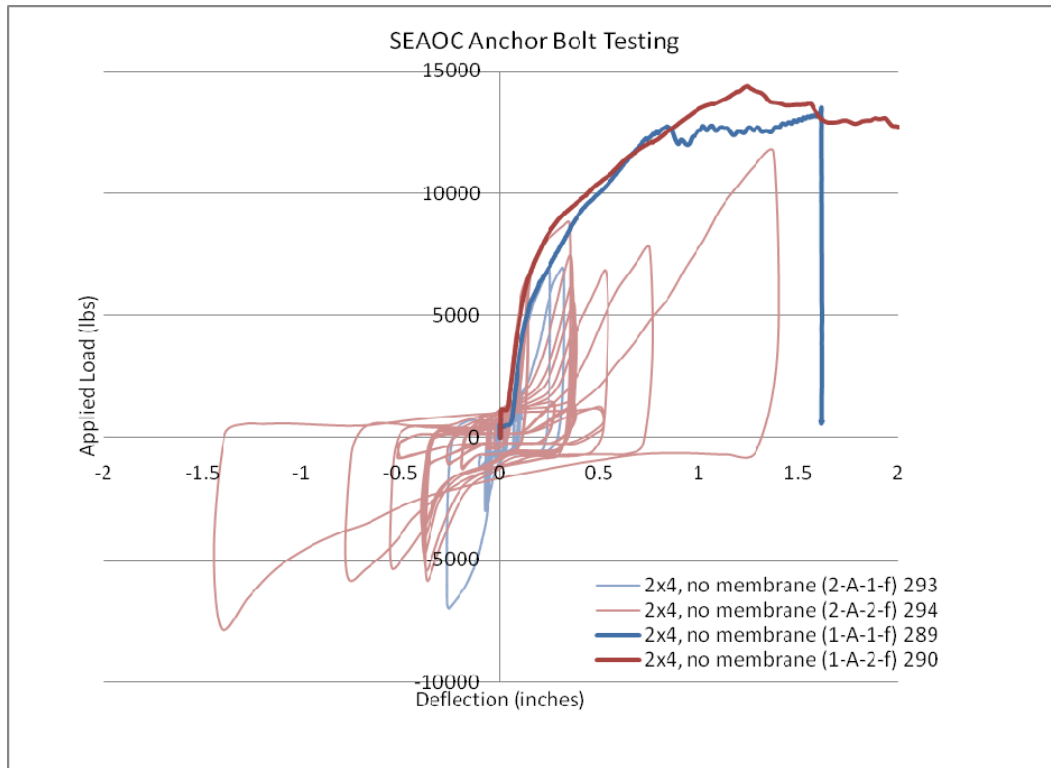
Chart 1 – Cyclic Tests (293, 294) vs Monotonic Tests (289, 290)

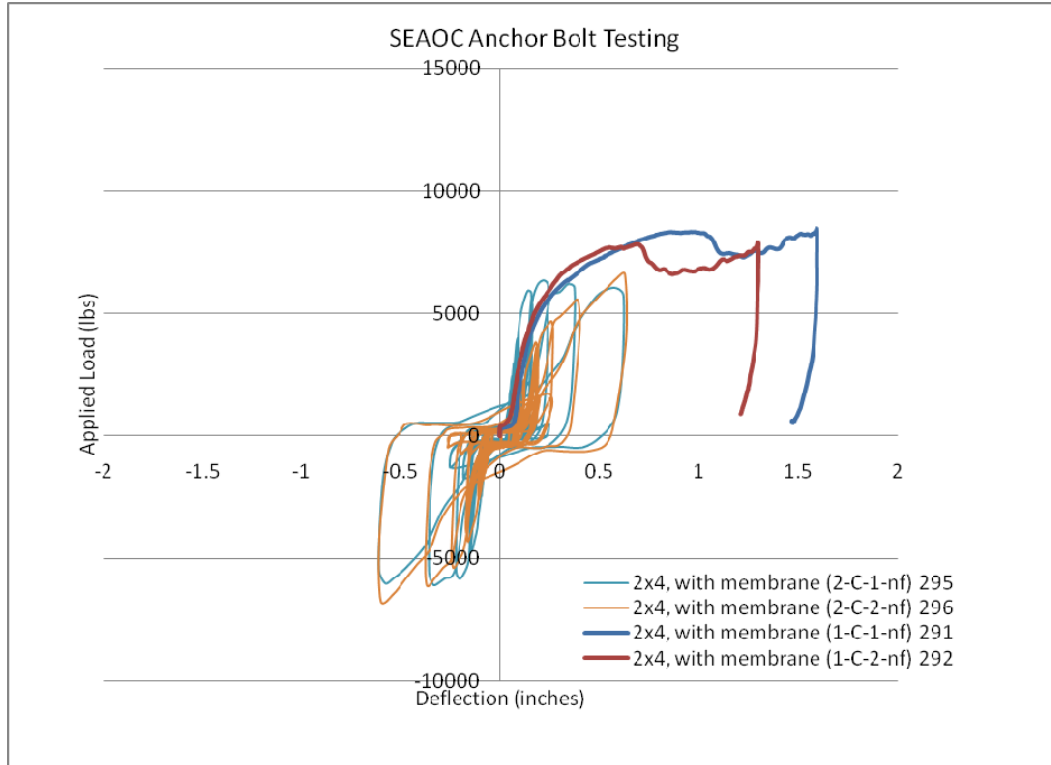
Chart 2 - Cyclic Tests (295, 296) vs Monotonic Tests (291, 292)

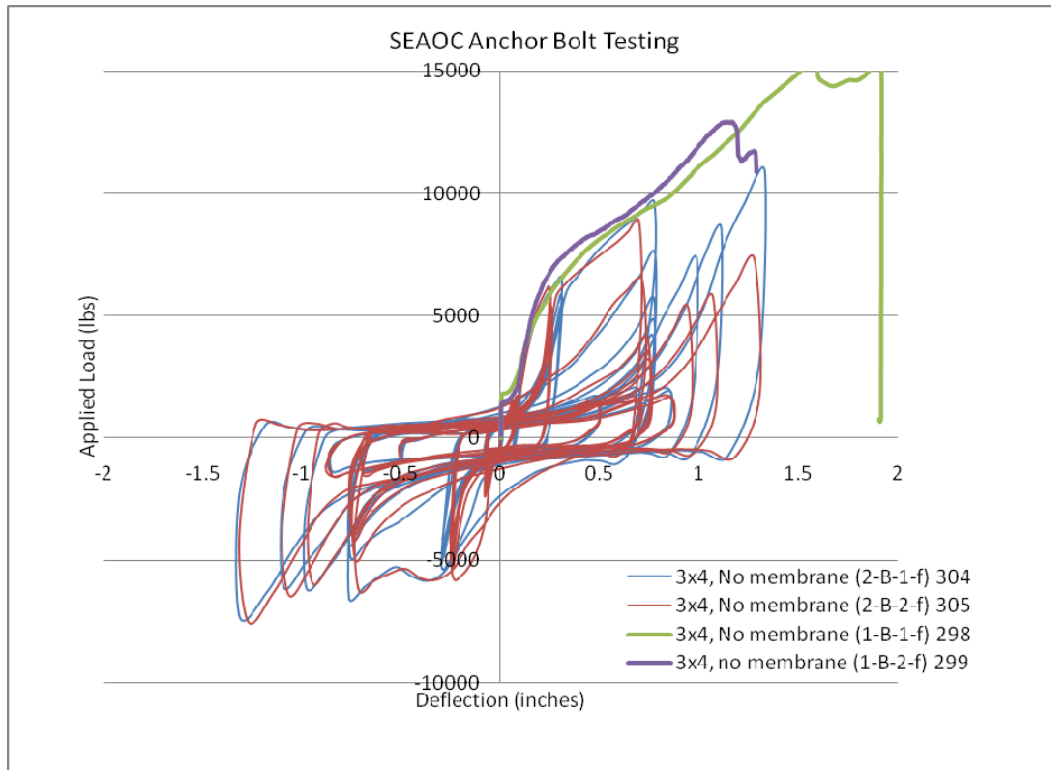
Chart 3 - Cyclic Tests (304, 305) vs Monotonic Tests (298, 299)

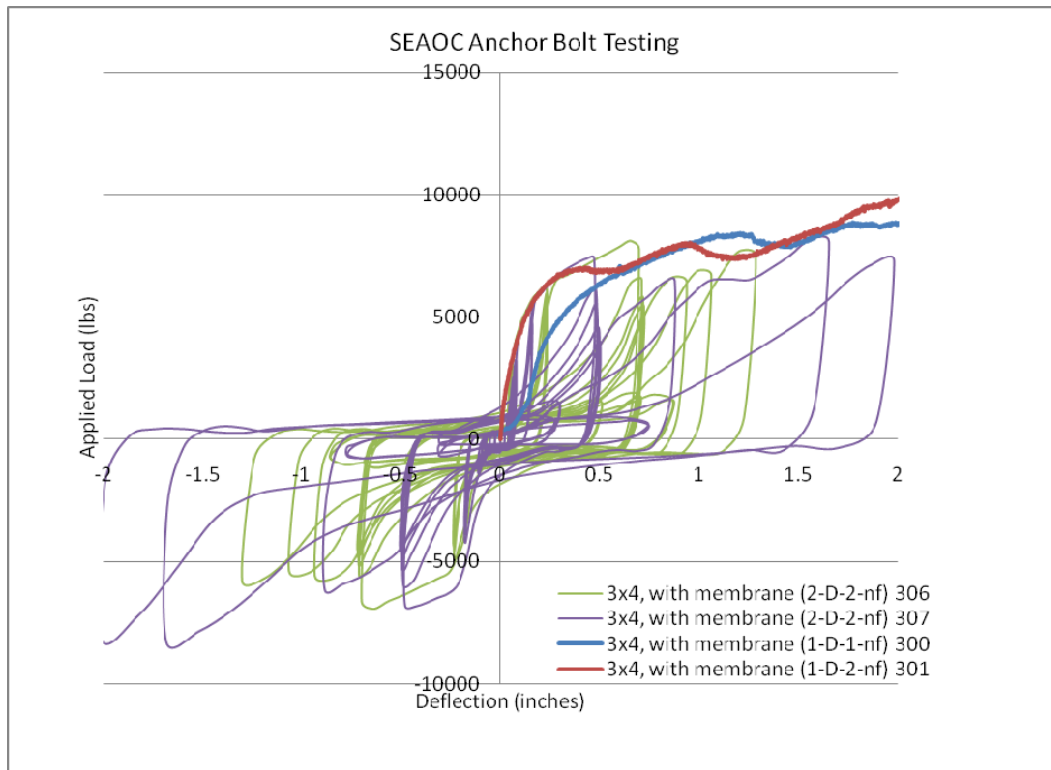
Chart 4 - Cyclic Tests (306, 307) vs Monotonic Tests (300, 301)

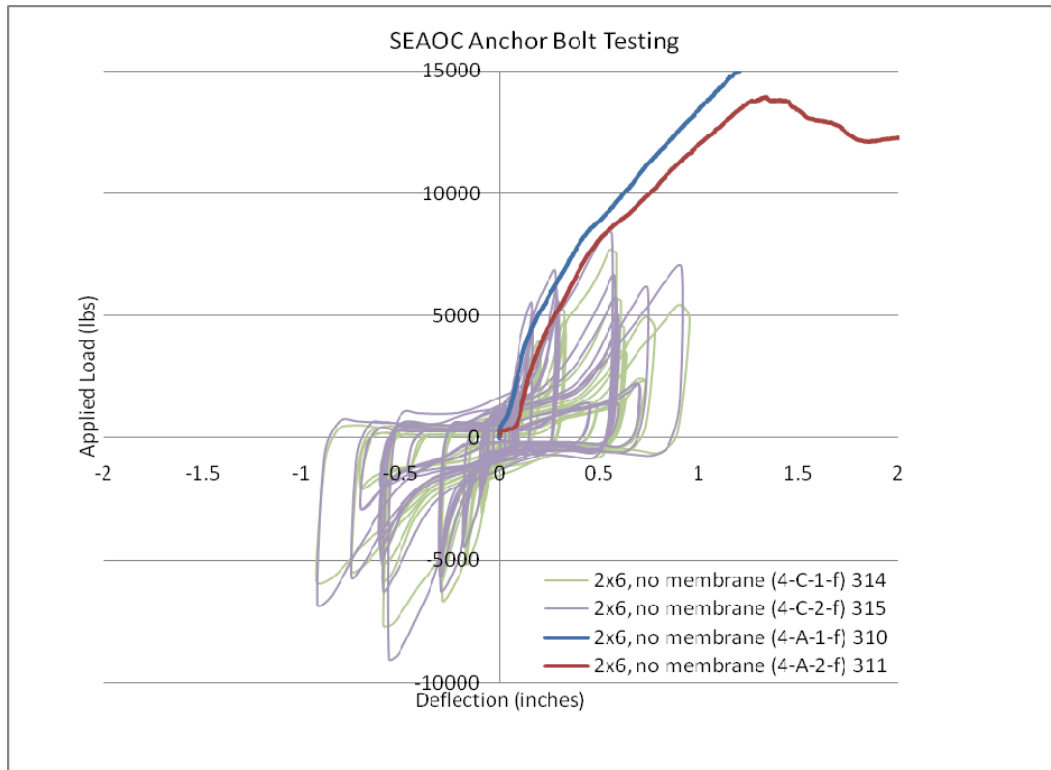
Chart 5 - Cyclic Tests (314, 315) vs Monotonic Tests (310, 311)

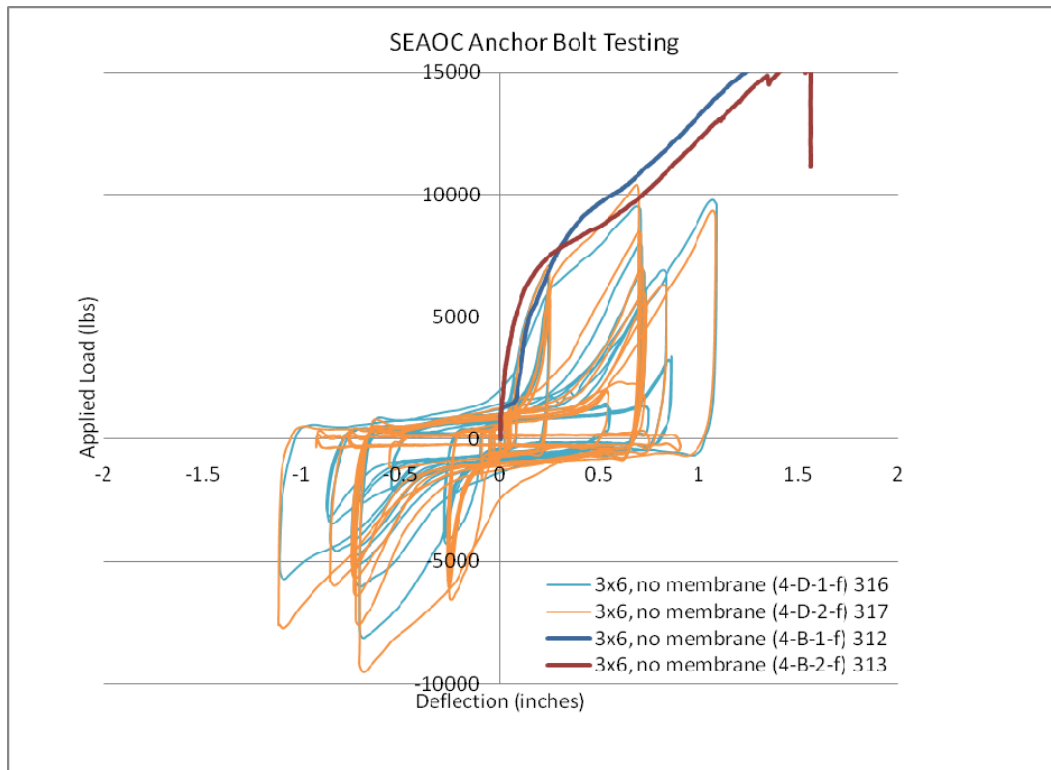
Chart 6 - Cyclic Tests (316, 317) vs Monotonic Tests (312, 313)

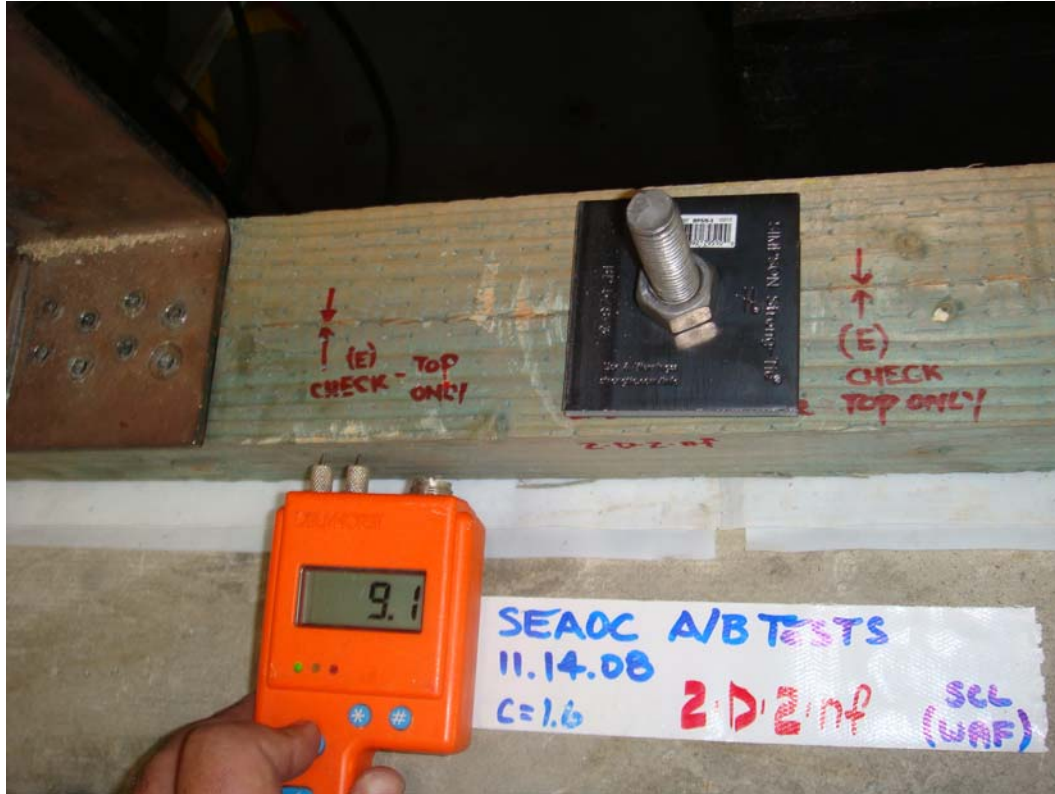
Image 4 – Pre-test documentation (typical).

Image 4 and **Image 5** show examples of pre-test and post-test documentation.

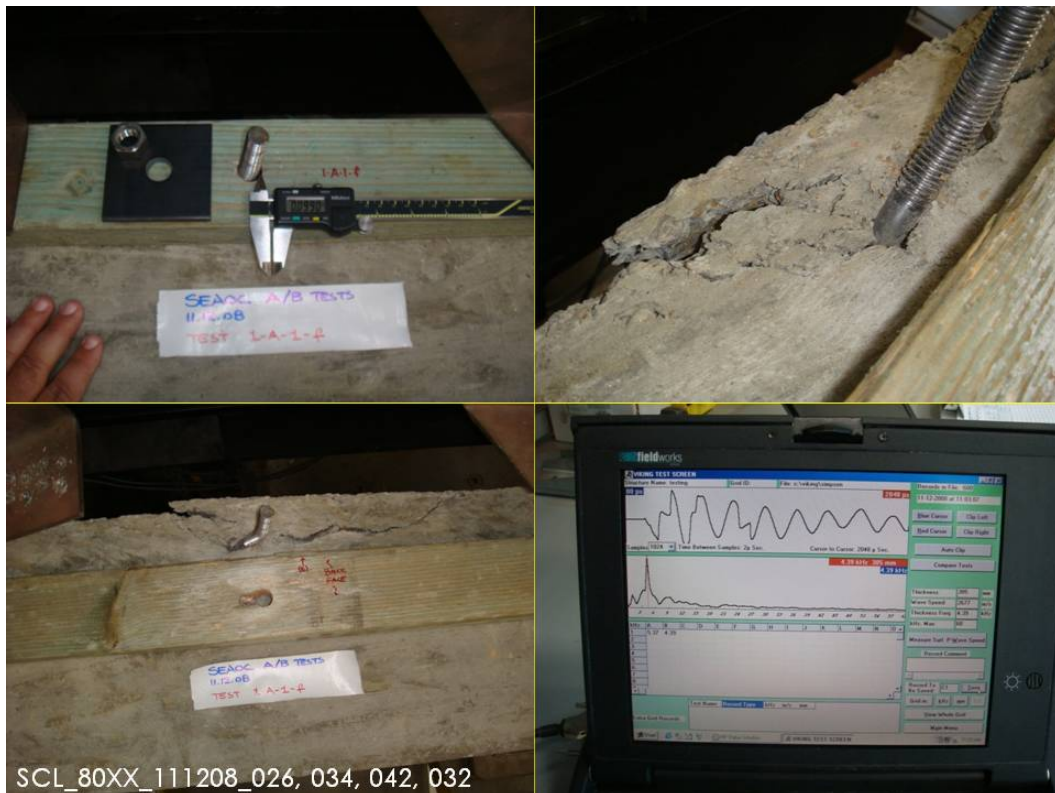
SCL_80XX_111208_026, 034, 042, 032

Image 5 – Post-test documentation (typical). Impact-echo testing shown in lower-right of image.

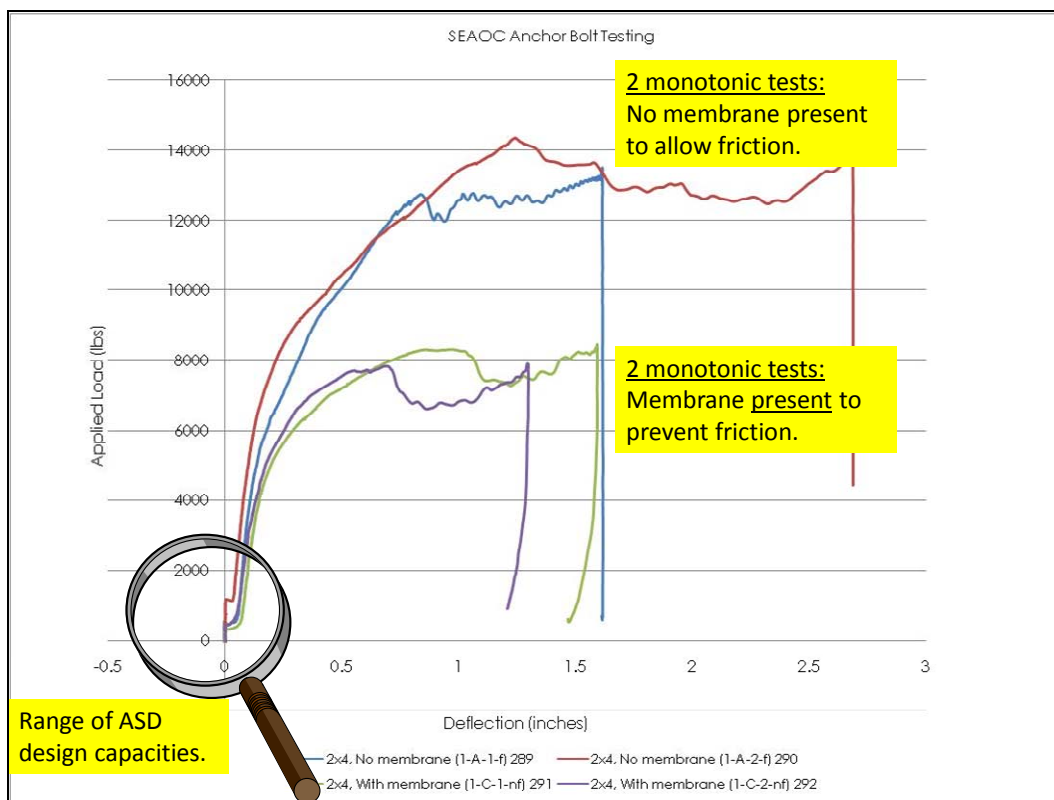
Chart 7 – Comparative plot of monotonic tests with (291, 292) & without (289, 290) membrane.

Effect of friction - Chart 7 shows comparative plots of monotonic tests conducted “with” and “without” the membrane. The membrane created an idealized frictionless plane between the wood sill plate and the surface of the concrete. As shown in Chart 7, the friction effect is negligible at small displacement in the range of the allowable design capacities but has a distinguishable effect at relatively large loads and displacements. The effect of the membrane on load and displacement response in cyclic tests was minor when compared to observations from monotonic tests.

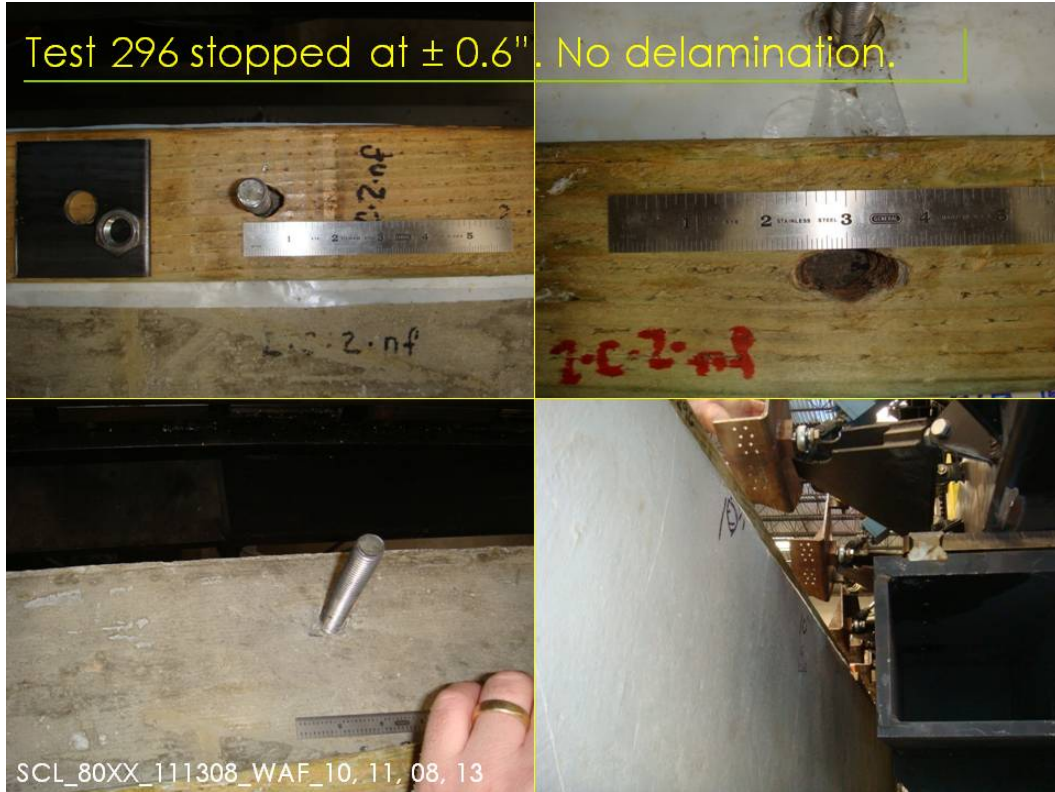
Image 6 – Composite imagery of “stopped” test (Test 296). See text for description.

After a number of tests where concrete delaminations were documented at displacements beyond 0.5” it was decided to stop cyclic test 296 at approximately 0.60” displacement. The sill plate was unbolted and documented. The specimen conditions after test 296 are shown in **Image 6**. The concrete remained unflawed as confirmed visually and with impact-echo. The same anchor was then re-tested using one of the spare tests (Test 302). A new piece of sill plate was bolted down and subjected to a SPD protocol. The resulting load-displacement plots for both Tests 296 and 302 are shown on **Chart 8**.

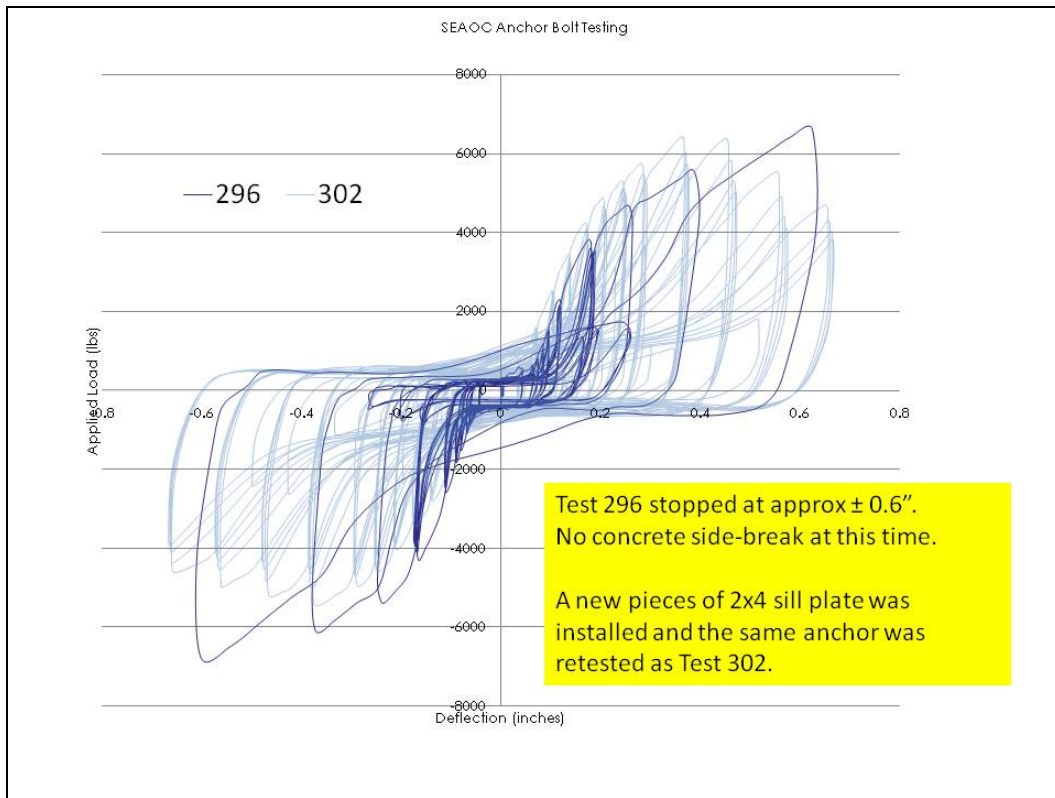
Chart 8 – Composite plot of Tests 296 and 302.

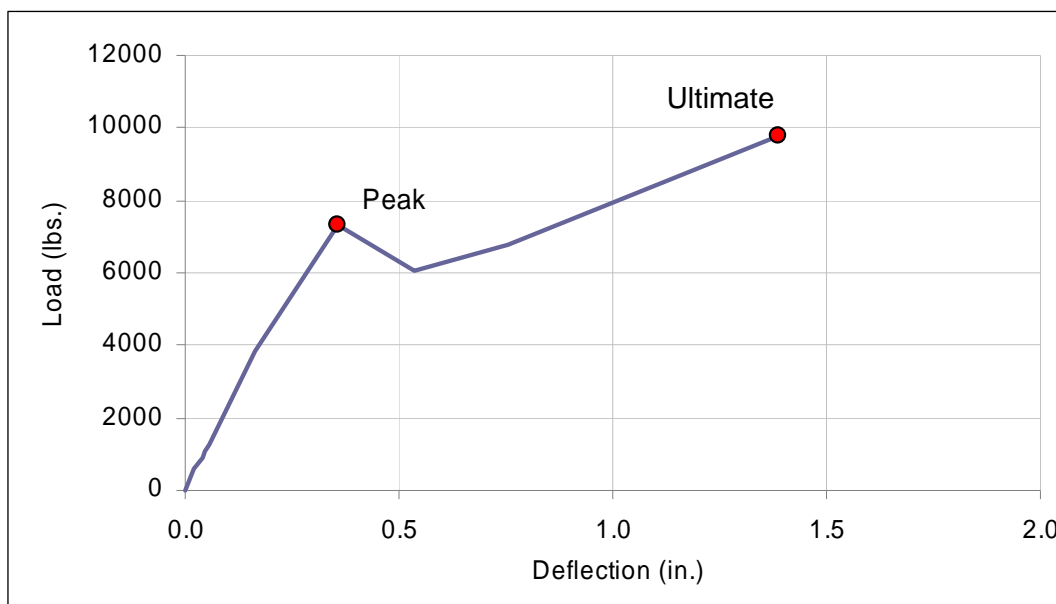
Figure 2 - Average envelope curve from cyclic tests (Specimen 294 shown).

All cyclic test data was analyzed in accordance with ASTM E 2126 *Standard Test Methods for Cyclic (Reversed) Load Test for Shear Resistance of Walls for Buildings (Reference 6)*. The positive and negative envelop curves for each specimens were combined to produce an average envelope curve used to establish peak load, displacement at peak load, ultimate load, and displacement at ultimate load as summarized in **Table 4**. Graphs of data are provided in **Appendix B**. Example load displacement hysteresis curves are shown in **Charts 1 through 6**. An example average envelope curve is shown in **Figure 2**.

The “saw tooth” pattern shown in **Figure 2** was observed for tests using the SEAOc Modified protocol. For purposes of this study, “Peak” load was assigned to the highest load reached prior to a drop in load level of at least 5% which is a departure from ASTM E2126 where peak is defined as the maximum load. The revised definition of “Peak” used in this report intends to address first signs of noticeable strength loss and also corresponds to first signs of onset of concrete side break-out. Ultimate load, as used in this study, is the last data point with value greater than 0.8 Peak. The “Ultimate” load, as presented in this report, is the load at maximum displacement prior to stopping the test. However, if the load at maximum displacement is smaller than 0.8 Peak load then 0.8 Peak load and the corresponding displacement is reported as “Ultimate”.

In **Figure 2**, the drop in strength and stiffness immediately following peak load coincides with initial detection of concrete damage. This damage is believed to reduce concrete bearing support for the anchor bolt leading to both increased anchor bending stresses and loss of stiffness. As displacement increases, the anchor becomes increasingly stressed in tension in addition to bending and shear. Tension forces are resisted by anchor embedment in concrete and wood bearing under the plate washer to produce a “clamping” of the wood member to the concrete foundation. Increased load resistance, beyond that associated with “Peak” load, was commonly observed at increasing displacement and is attributed to the tensile resistance provided by the anchor after fastener yielding. These increased loads and deflections are associated with “Ultimate” load data in **Table 4** (see **Appendix B**).

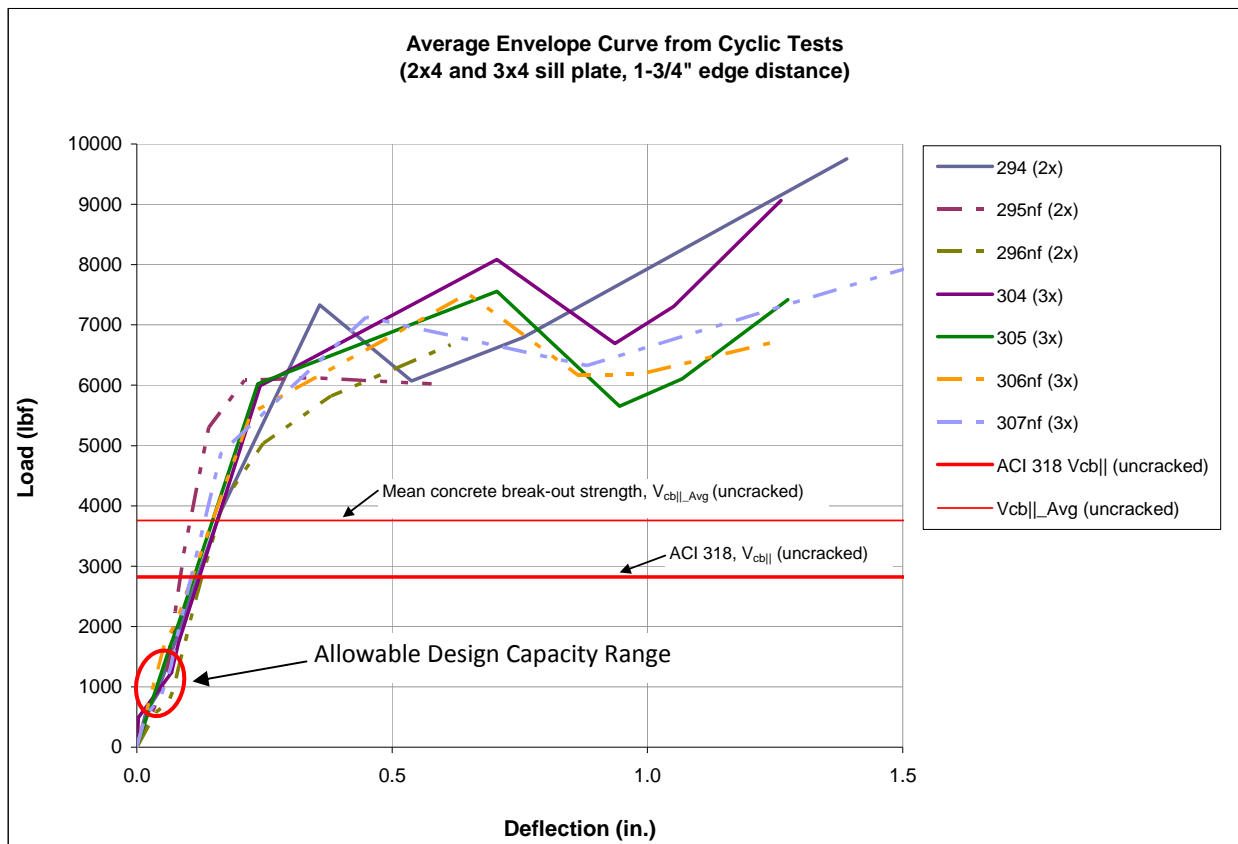
Chart 9 – Average envelope curves for 2x4 & 3x4 cyclic tests

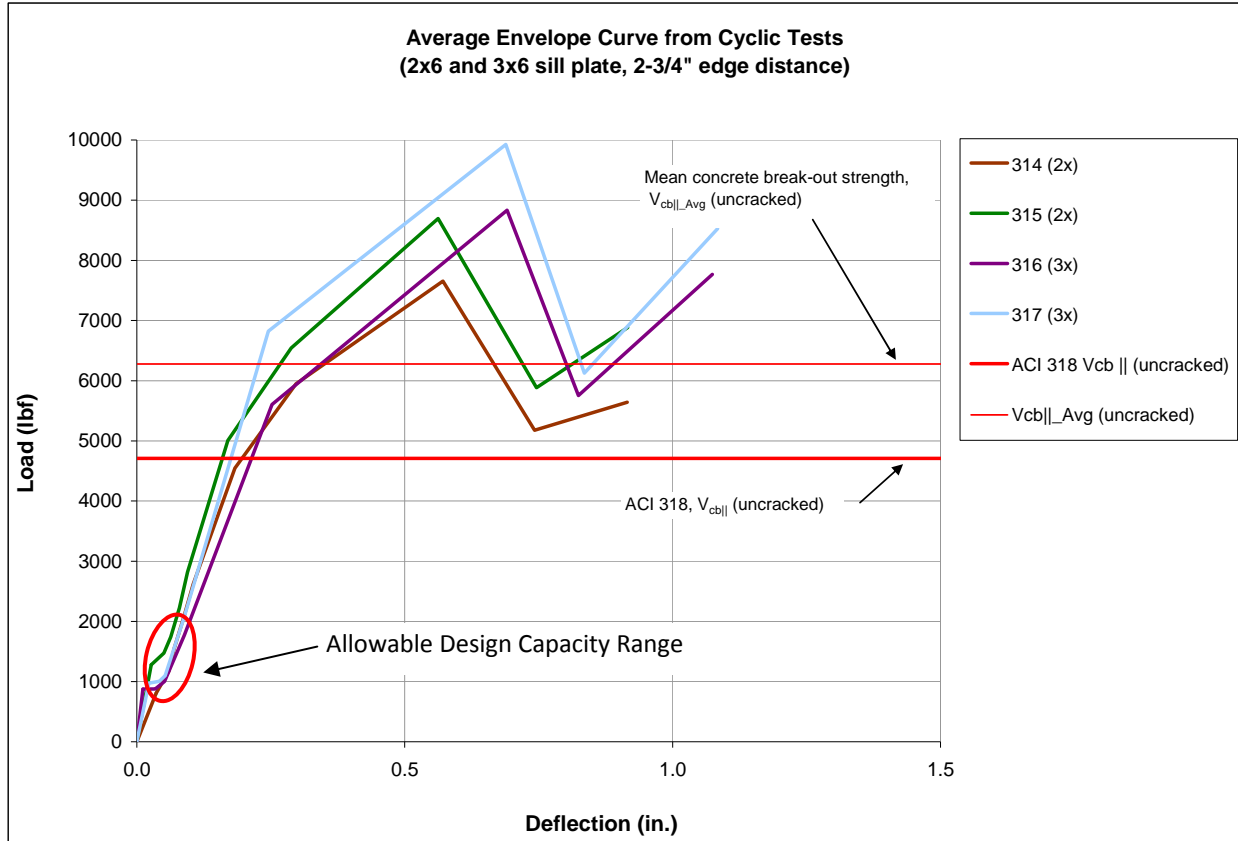
Chart 10 – Average envelope curves for 2x6 and 3x6 cyclic tests.

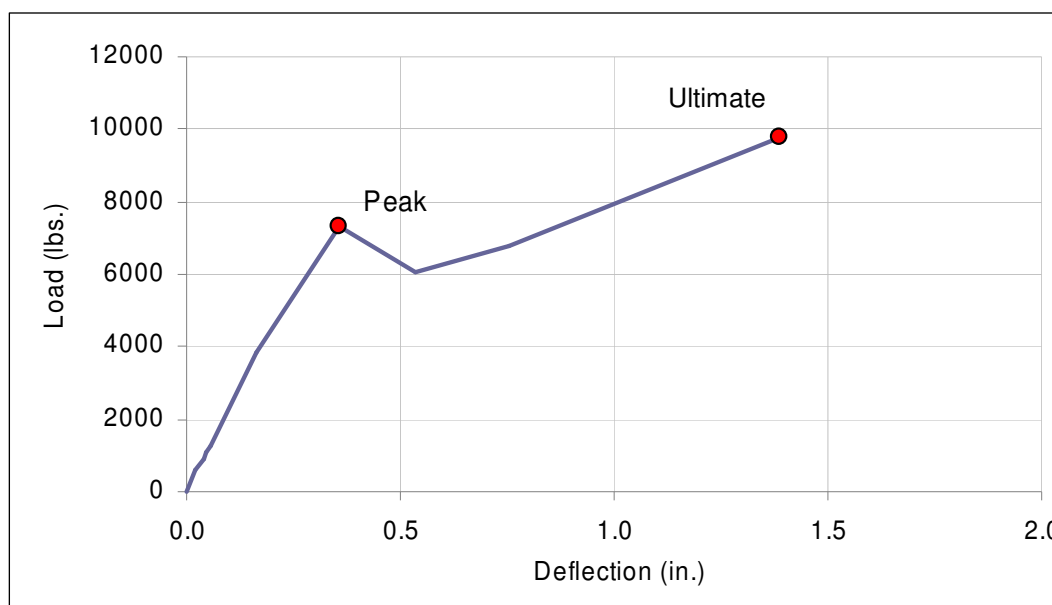
Figure 1: Typical inelastic behavior showing secondary peak.

Third, the class of anchorage tested was ductile, and concrete side-breakout was not detected until the resistance force was significantly beyond the elastic range, specifically not until the peak value was achieved. In addition to the observation of significant bolt bending, peak strengths from cyclic tests of the 1¾-inch edge distance case (e.g. 2x4 and 3x4 sill plate) ranged from 2.3 to 2.9 times the NDS calculated yield values for the wood sill plate connection, which indicates substantial loading beyond the yield limit state of the connection. The peak value was generally accompanied by a complete, but shallow concrete delamination. Use of the impact-echo measurements often signaled internal concrete delamination prior to any visual evidence, although no evidence of any sort was noted in the elastic range or below 6000 pounds in any test. After the initial shallow delamination occurred, the anchors were in tension, and a secondary peak was recorded--often with a higher ultimate value than the initial peak (see Figure 1). Significant ductile mechanisms were observed in the form of large deflections of the sill plate and bending of the anchor bolt. The failure mechanics of concrete predict that delaminations form initially from a series of micro-cracks. These internal micro-cracks propagate and interconnect along an eventual failure surface that corresponds roughly to the path of least energy. Although the study of fracture mechanics has not progressed to the point to have accurately predicted the information obtained from the SEAOB tests, it does predict significant energy can be absorbed by the concrete after the onset of inelastic behavior. The tests showed that in the post-elastic range, strength gain is slowed as micro-cracks grow to the point where the peak strength value occurs. The peak strength was noted to coincide with the point where initial delamination occurred.
